Ordinary Council Meeting Under Separate Cover Wednesday, 10 July 2024

This report has been prepared to assist Coonamble Shire Council in preparing a master plan for the site and existing buildings at the location. The purpose of this report is to describe the physical condition of the building and indicate the heritage significance of the structures and the site.

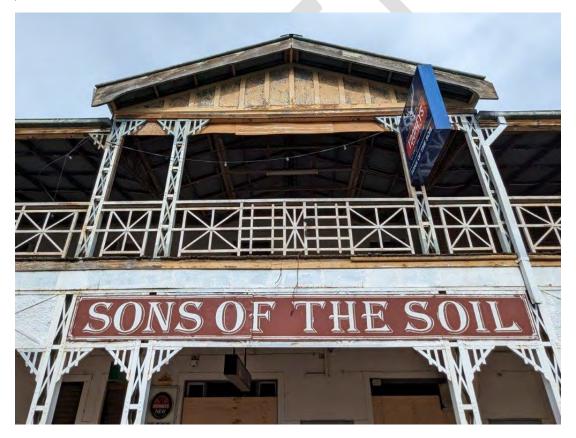
Photograph 9 The gabled pediment in the verandah façade provides the symmetrical feature on the elevation. The early Butlin Archive images indicate that the structural details to the verandah are original.

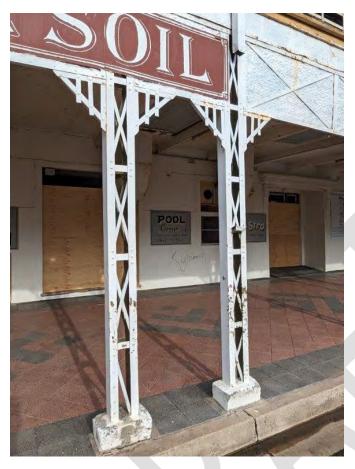
Photograph 10 A close detail of the verandah post steel structures, bases, decorative brackets and roughcast finished infill sheets with diagonal braces. The downpipes are missing.

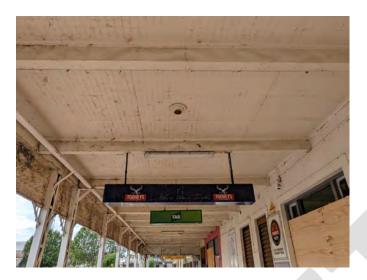
A view of the pressed metal verandah soffit, looking south, noting earlier light fittings and the later steel Photograph 11 brackets & batten on the posts

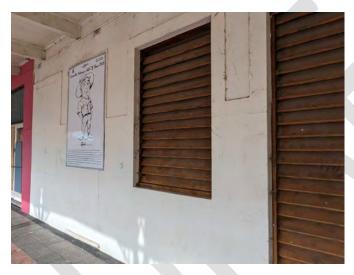
Photograph 14 The window and door openings have been modified as part of meeting the smoking requirements. Suitable replacement doors and windows could be reinstated.

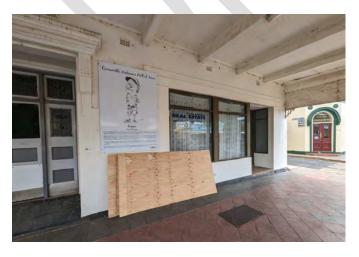
Photograph 20 The end of the elevation indicates the second retail shopfront which is a replacement for the original door and two windows. A suitable replacement could be provided for the uncharacteristic aluminium units.

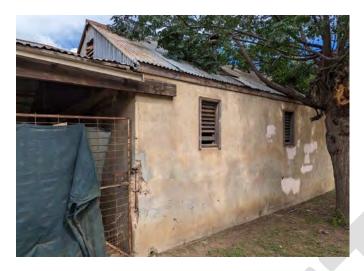
Photograph 23 The West elevation facing into Skillman's Lane noting overgrown tree, damaged roof, missing gutter and damaged corner of wall. These elements appear capable of restoration while the attached roof to the left is an extension and has minimal significance.

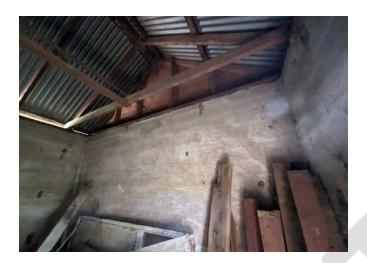
Photograph 25 An internal view of the walls and roof structure, noting the generally sound condition.

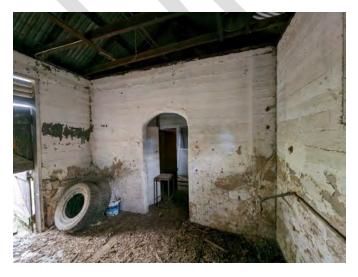
View of the eastern end noting the arched construction and damaged wall. Photograph 27

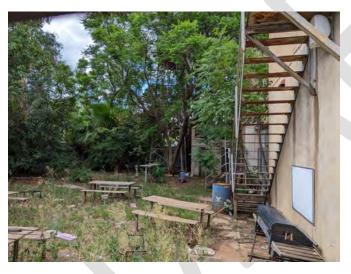
A view of the yard and West elevation with fire staircase and laundry from the north wing beyond. The Photograph 34 overgrown tree requires removal to reduce the impact of the roots on the building.

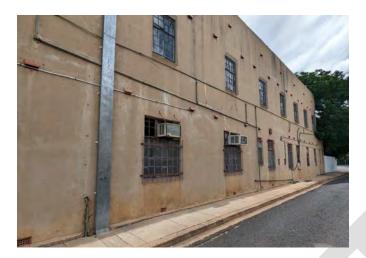
Photograph 51 View of the North elevation, looking west, noting the extent of glass repair required to the windows

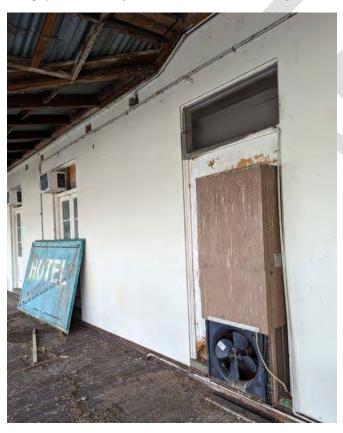
Air conditioning systems for the bar in this central area have damaged the front elevation which can be Photograph 58 restored.

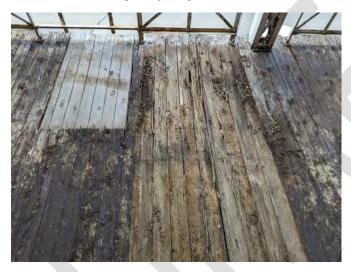
A close view of damaged flooring & part replacement floorboards near the AC installation. Photograph 60

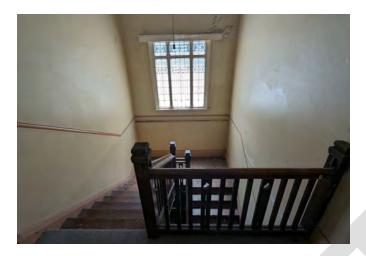
Photograph 100 A view from the upper landing, noting the decorative leadlight window. Note the minor water damage in the top corner of the wall.

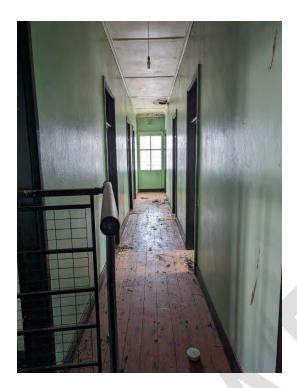
Photograph 128 General view looking south to the end of the wing, noting the ceiling damage and pigeon infestation.

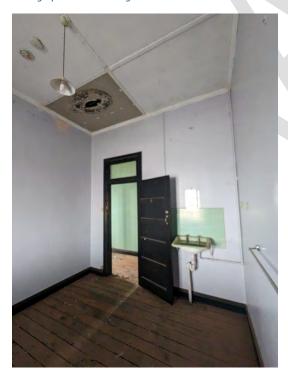
Internal view of Room No.9 noting ceiling damage.

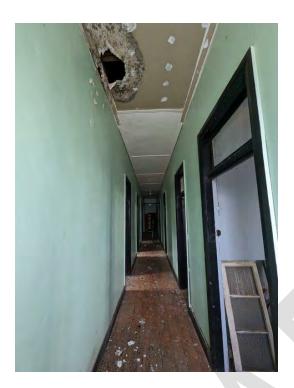
Photograph 136 View looking back north along the hall, noting the ceiling damage (also shown in photograph 128).

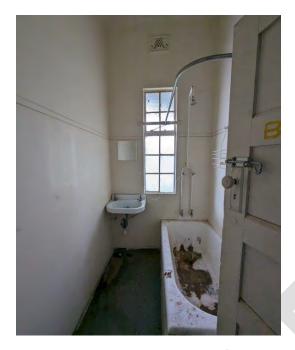
Photograph 138 View of the bathroom and rusted bath unit

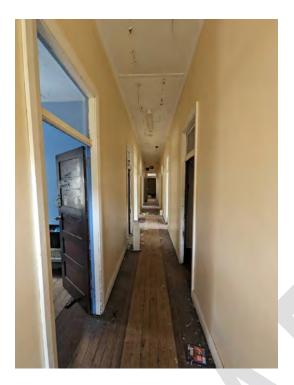
Photograph 146 A general view looking east, noting the pigeon damage due to a major infestation through open windows on the southern side of the wing.

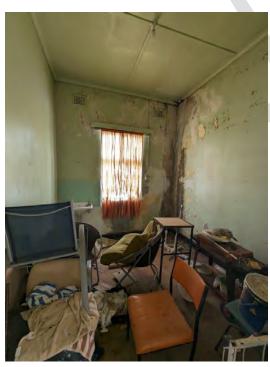
Photograph 147 View of the room interior, noting the condition. The room size is smaller than the original rooms. Thecondition is poor with damage due to roof leaks. It appears that this wing has not been utilised for some years for guest accommodation.

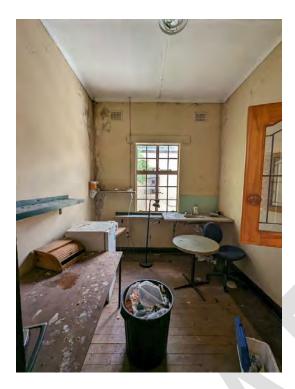
Photograph 148 The end room on the north side, noting the poor condition.

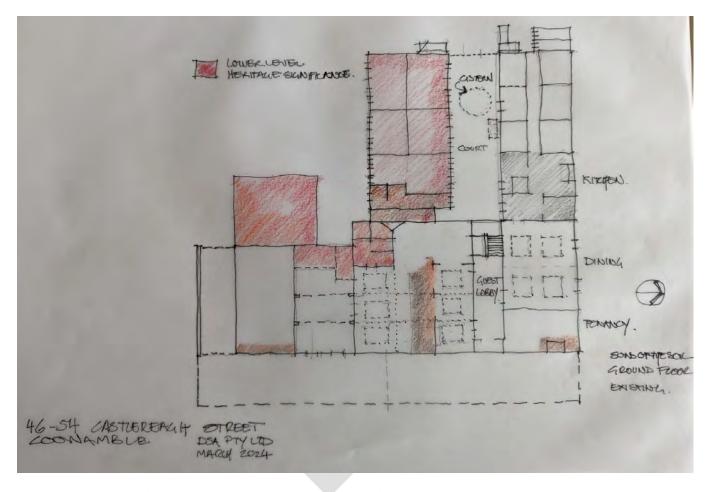
Drawing 2 The parts of the building noted in the report as having a low level of Heritage significance are highlighted in Red. These are those which are in a Poor condition, have been substantially altered or have been changed into a state which is uncharacteristic of the significant 1930 building. Dotted/dashed elements are details with heritage significance such as ceilings and bulkheads.

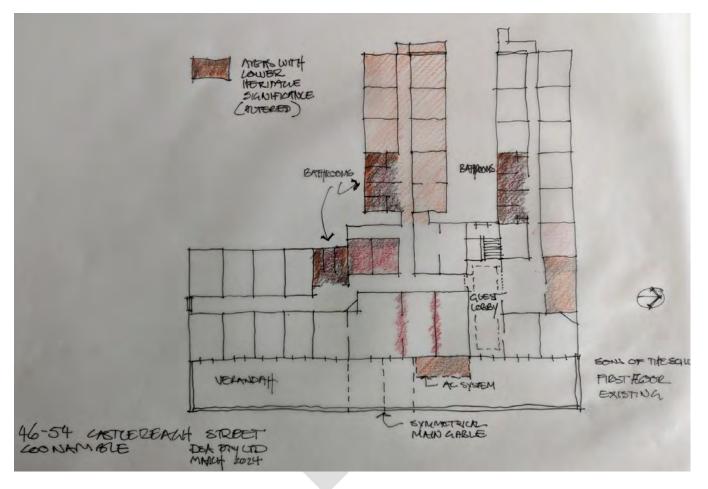
Drawing 3 The first floor provides 28 standard guest rooms with handbasins, a set of rooms including a kitchen and dining space for the manager and a guest lounge. Each of the three wings has a bathroom with toilets and baths. The central extension wing is in a Poor condition.

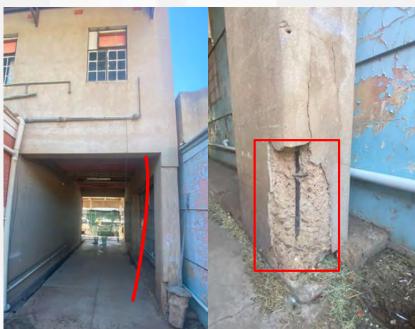
Figure 20: Columns at the southern end of the building are beginning to buckle with concrete breaking away from reinforcement. Structure may become unstable with more soil and building movement.

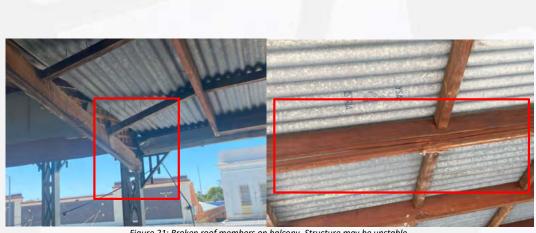
Figure 21: Broken roof members on balcony. Structure may be unstable.

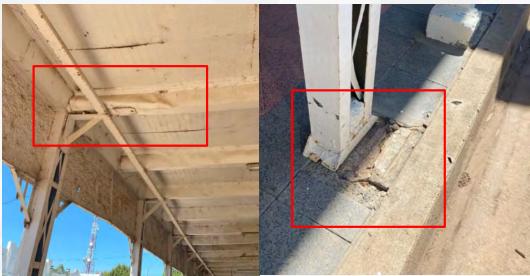
Figure 22: A number of floor beams were observed to be broken. Column displaced from footing. Structure may be unstable.

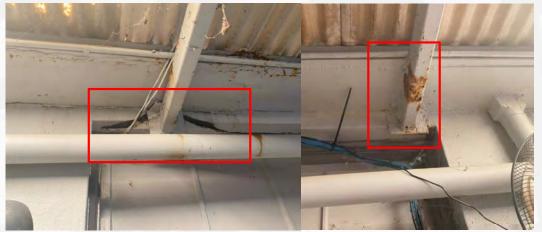
Figure 23: Outdoor roof structure, between the two western wings of the building has detached beams or heavily corroded members.

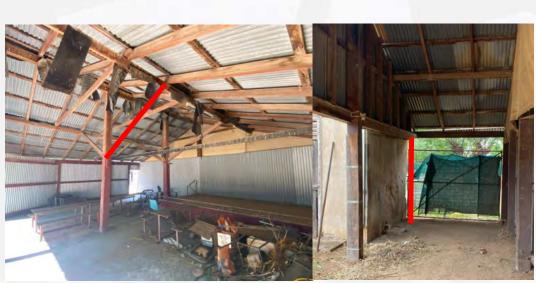
Figure 24: Missing members from outdoor timber structure. Structure may be unstable.

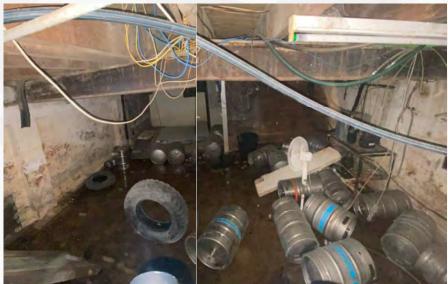
Figure 26: Water ingress into cellar. This will deteriorate timber members and corrode steel members. In addition, this will damage masonry structures.
